# Experimental analysis of Implant–cement interfacial behaviour under shear mode loading conditions

**Abstract:** The failure of the bone cement (PMMA) is the most prominent scenario, in a cemented total hip arthroplasty and an eventual implant loosening. Among the many factors influencing the long-term stability of cemented hip prostheses, the interface between the implant and bone cement is considered to be one of the most susceptible to failure. Implant surface roughness is an important parameter affecting the fracture behavior of the implant–cement interface. This study investigated the influence of implant surface roughness on the resistance of the implant–cement interface. Mechanical fixation at the implant–cement interface was evaluated in vitro using shear loading with stainless steel rods with different surface roughness preparations. Increasing surface roughness improved the mechanical properties at the implant–cement interface. Therefore, it increases the long-term stability of the hip prostheses assembly.

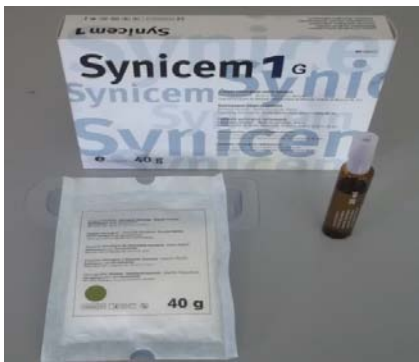
**Fig. 2 Two components of PMMA: powder (polymer) and liquid (monomer)**

The surface roughness variations were obtained by waterproof silicon carbide with different grit sizes (1000, 800, 500, 320 and 220). Subsequently, the adherence of bone cement (Figure 2) to the steel specimens is done by the moulds. Prior to testing, the specimens were cleaned with acetone and placed in a Teflon mould. We hand-mixed the cement for 2 min before pouring it into the mould which contained steel sample. The cement was injected in the cylindrical
